## Electrical System

## Observations and Recommendations

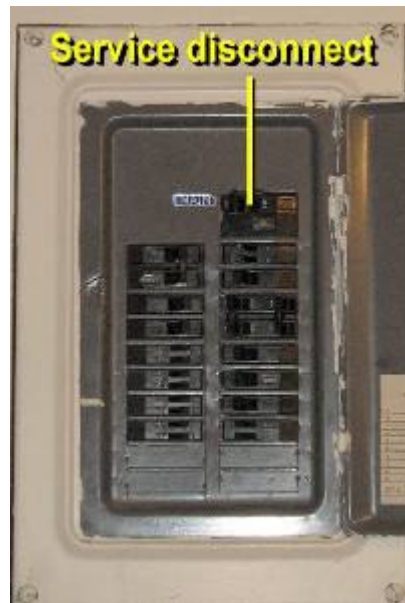
The 120/240 volt service enters the house via an overhead service drop to a meter located at the south side of the house. The seal on the meter is intact.

The main service panel is a 100-amp Square-D product containing breakers located in the basement. The service disconnect is one 100 amp breaker located here. The panel was opened and examined. The service entrance wire appears to be 2 AWG copper. All breakers appear to be appropriate for the observed wire sizes. There are some unused breaker slots allowing for expansion of the system. The circuits were labeled on an attached list.

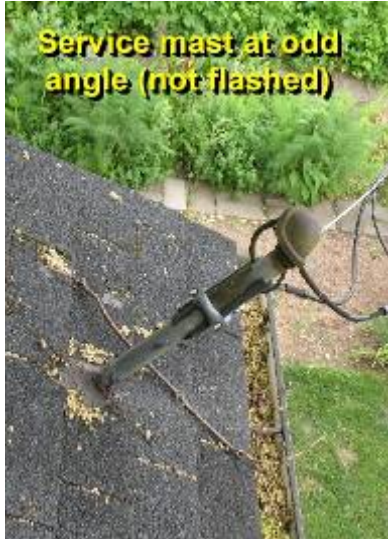
**REPAIR:** The service entrance mast is at an odd angle and I suspect the conduit has bent and is in need of replacement.

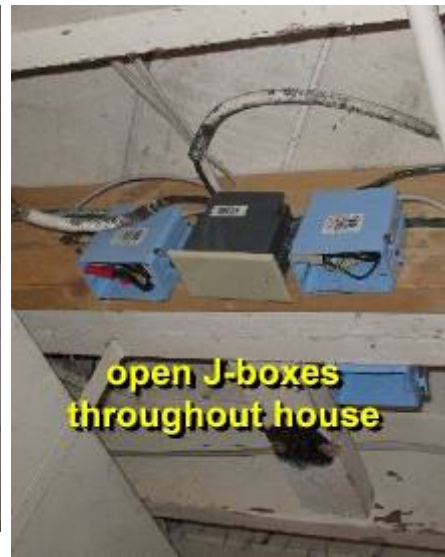
**SAFETY CONCERN INVESTIGATE FURTHER** and **REPAIR:** In addition to the older wiring, much of the newer wiring has open junction boxes including one dangling live cable in the basement. This is indicative that the newer wiring was not done by a licensed professional. **I recommend a qualified licensed electrician fully evaluate the newer wiring and make repairs as needed.**
