**Complete Wood Destroying Organisms Inspection Report**  
(Structural Pest Inspection)

Address: **12345 Pleasant Ave**  
**Seattle, WA 98100**  
Prepared for: **Jack & Jill Client**

**ICN # Sample**  
Date Inspected: **April 1st, 2003**  
Report # **030401X** Visit: **#1**  
Inspected by: **Richard Moore**  
WSDA License # **66155**

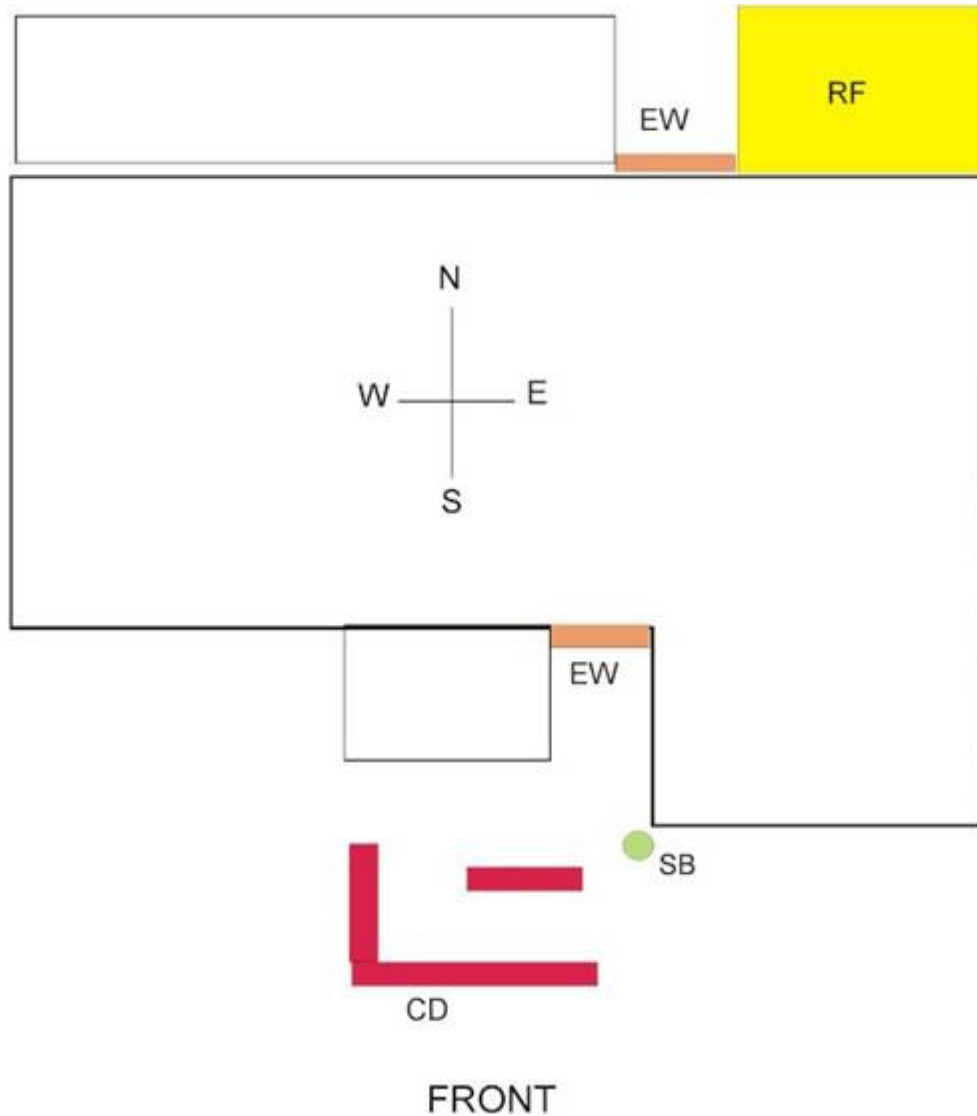
## Wood Destroying Organisms Inspection Report Diagram

Observation	Description, Location and Recommendation
<b>Missing Splash-Block (SB)</b>	The downspout at the SW corner of the garage discharges too close to the house. Recommend you install extensions or drain-blocks in this area to ensure run-off is directed well away from the structure.
<b>Conductive Debris (CD)</b>	There is a lot of decayed wood in the landscape timbers at the front walkway. While none of this is a "direct" threat to the home it is a possible attractant for wood destroying insects that may later move into the home. I recommend that as much of this as possible be removed and, where needed, replaced with pressure treated lumber or other non-wood materials.
<b>Earth-Wood contact (EW)</b>	There are a number of areas around the house where soil is in contact with the siding. This can result in moisture damage and/or insect infestation of the exterior envelope. Ideally, there should be at least 6" of <b>clean concrete</b> between the soil and siding. On older houses, because of the accumulation of topsoils and settling, this may not be feasible in all areas but I strongly recommend that an absolute minimum of 2" of clearance be achieved and that these "minimal" areas be monitored on a regular basis to prevent debris, leaves, etc from compromising this gap. The noted areas were at the front near the gas meter, at the rear between the two decks, and minimal clearance on the west side (south end).

<b>Rot Fungus (RF)</b>	Many of the joists under the smaller, east rear deck are extremely decayed from rot fungus. I believe that portions of this deck are near collapse. All of the joists showing any signs of decay should be replaced, which will essentially require rebuilding a large portion of this deck.
