## Electrical System

## Observations and Recommendations

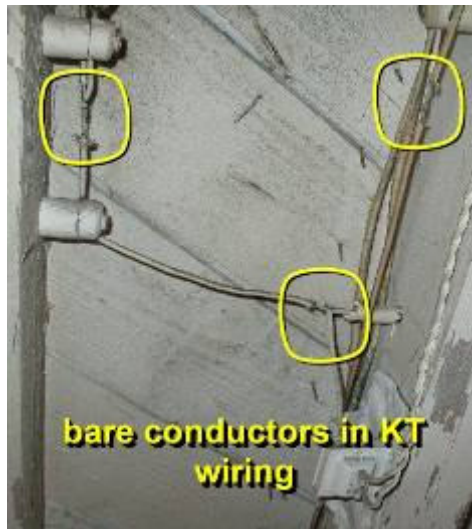
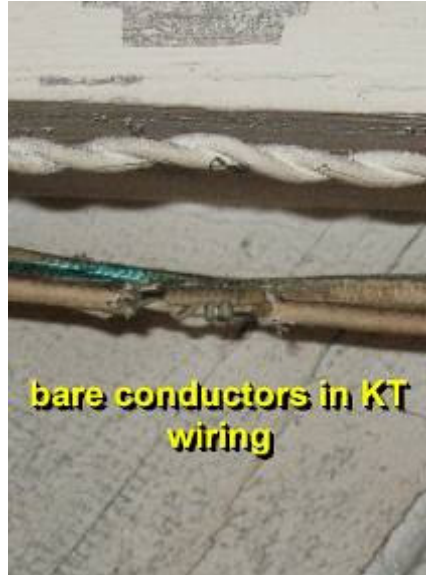
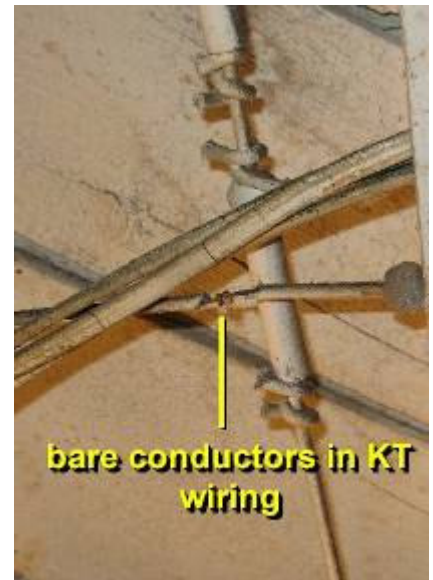
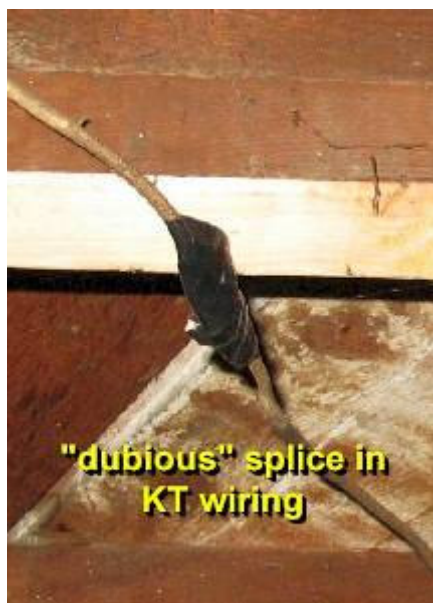
**SAFETY CONCERN INVESTIGATE FURTHER** and **REPAIR:** Although some of the distribution wiring has been upgraded there remains much of the original knob and tube wiring in use. Much of this was visible in the basement and crawl areas while some **remains hidden** and was “deduced” from the ungrounded receptacles (original and ungrounded 3-prong). When in good condition, there is nothing wrong with this older style of wiring other than it does not have a grounding conductor, although care should be taken with insulation and load. Some insurance companies are refusing to issue new policies for homes still wired in this fashion.

In this case there are a number of areas where the rubber insulation is missing, exposing bare and live conductors. There are a number of incorrect splices and some of the support knobs and tubes are misplaced. When KT wiring is in this condition I have no alternative but to **recommend a qualified licensed electrician fully evaluate the wiring and make repairs as needed**. That “repair” will undoubtedly be to fully upgrade the wiring.

**SAFETY CONCERN INVESTIGATE FURTHER** and **REPAIR:** In addition to the older wiring, much of the newer wiring has open junction boxes including one dangling live cable in the basement. This is indicative that the newer wiring was not done by a licensed professional. **I recommend a qualified licensed electrician fully evaluate the newer wiring and make repairs as needed.**

**INVESTIGATE FURTHER: CONCLUSION:** From the service mast, to the meter box, panel, and distribution wiring, this home is in serious need of electrical upgrade. **I recommend you get a number of estimates from qualified electrical contractors to bring this home's electrical systems up to modern standards.**
